**DEPARTMENT OF TRANSPORTATION**

Quality Assurance and Source Inspection

Contract #: 04-0120F4Cty: SF/ALA Rte: 80 PM: 13.2/13.9File #: 69.28**WELDING INSPECTION REPORT****Resident Engineer:**Pursell, Gary**Address:** 333 Burma Road**City:** Oakland, CA 94607**Report No:** WIR-001427**Date Inspected:** 23-Jan-2008**Project Name:** SAS Superstructure**OSM Arrival Time:** 800**Prime Contractor:** American Bridge/Fluor Enterprises, a JV**OSM Departure Time:** 1430**Contractor:** Zhenhua Port Machinery Company, Ltd (ZPMC), Changxing Island **Location:** Shanghai, China

# WELDING INSPECTION REPORT

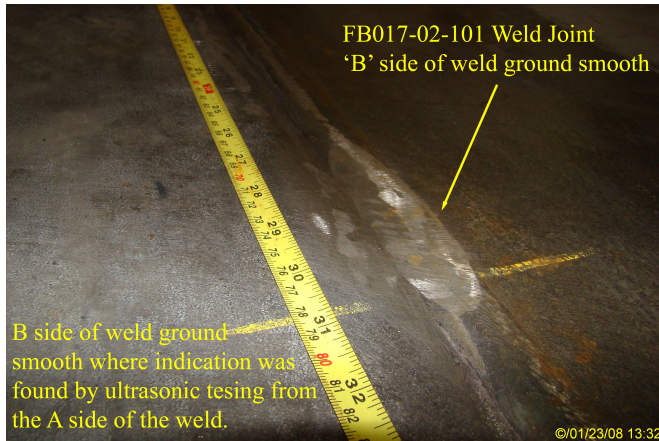
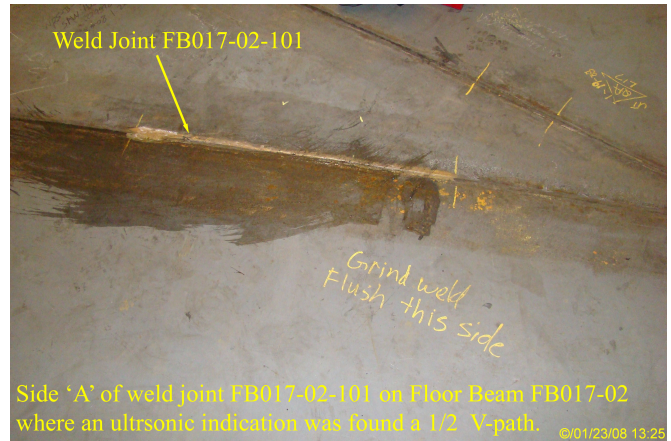
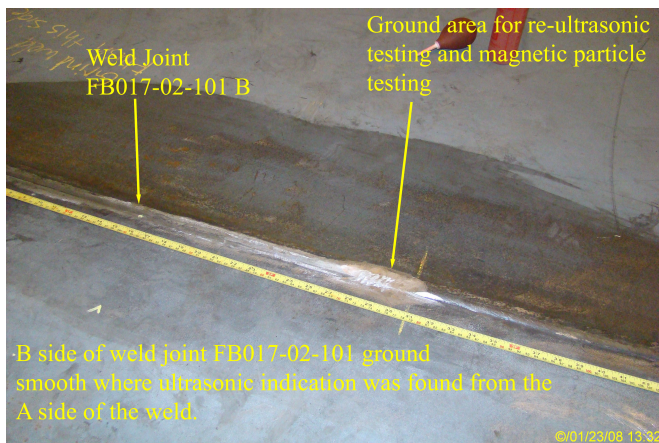
This Quality Assurance Inspector reviewed the radiographic film for three OBG bottom plate complete joint penetration welds accepted by quality control. During the review one of the welds was found to be unacceptable and Mr. Kevin Carpenter of American Bridge / Fluor was notified. Mr. Carpenter who had also reviewed the film came to the Quality Assurance Office to reread the film and agreed with the quality assurance call. An Incident Report was written and submitted by this Quality Assurance Inspector. For details see Radiographic Report TL-6029 dated January 23, 2008.

This Quality Assurance Inspector performed magnetic particle testing on transition weld joint FB017-02-101 after transition side of the weld was ground smooth. Ultrasonic testing had found a recordable indication during examination both before and after contouring of the weld. The indication appeared to be a one half skip distance or the depth of the plate running the full length of the weld. Magnetic Particle Testing was carried out in both the AC & DC mode with the primary direction of inspection looking for longitudinal indications. No indications were observed so the probable cause of the indication is suspected to be weld geometry. For detail see magnetic particle testing report TL-6028 dated January 23, 2008.
